REPORT OF  
INVESTIGATION & DEVELOPMENT  
OF  
PRELIMINARY COSTS TO REHABILITATE  
WORSHAM STREET BRIDGE

FOR  
CITY OF DANVILLE, VIRGINIA  
DEPARTMENT OF PUBLIC WORKS

AUGUST 2, 2004

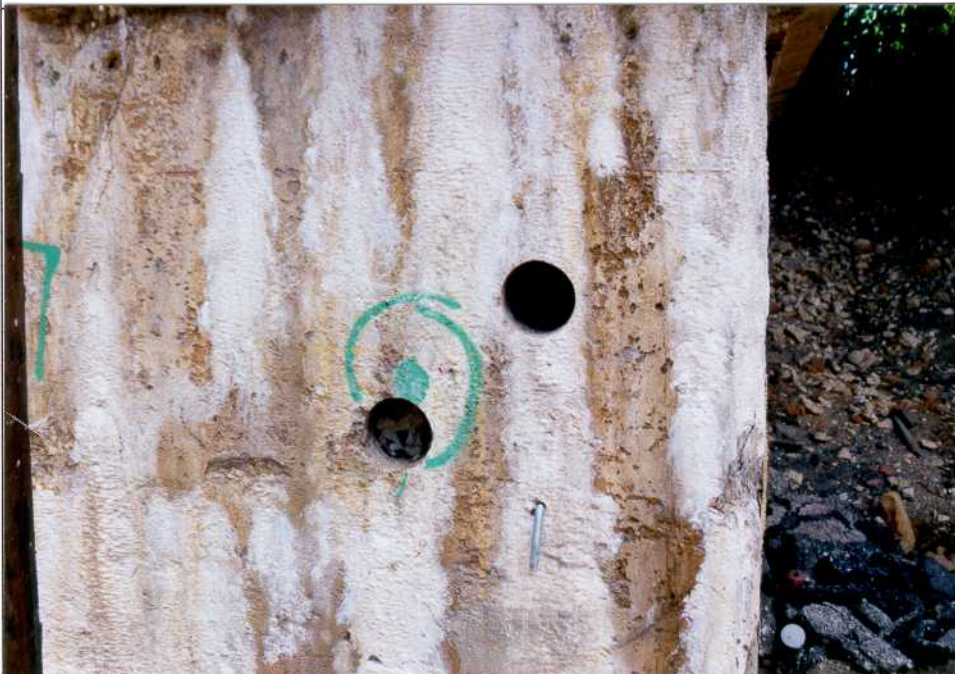
C216-12

PIER #9, UPSTREAM FACE, 3' BELOW TOP OF CAP - CORE  
HOLES #7 AND F.

- Core F: Minor amount of reaction observed. Small coarse aggregate particles showed evidence of minimal gel deposits at the boundary of the aggregate.

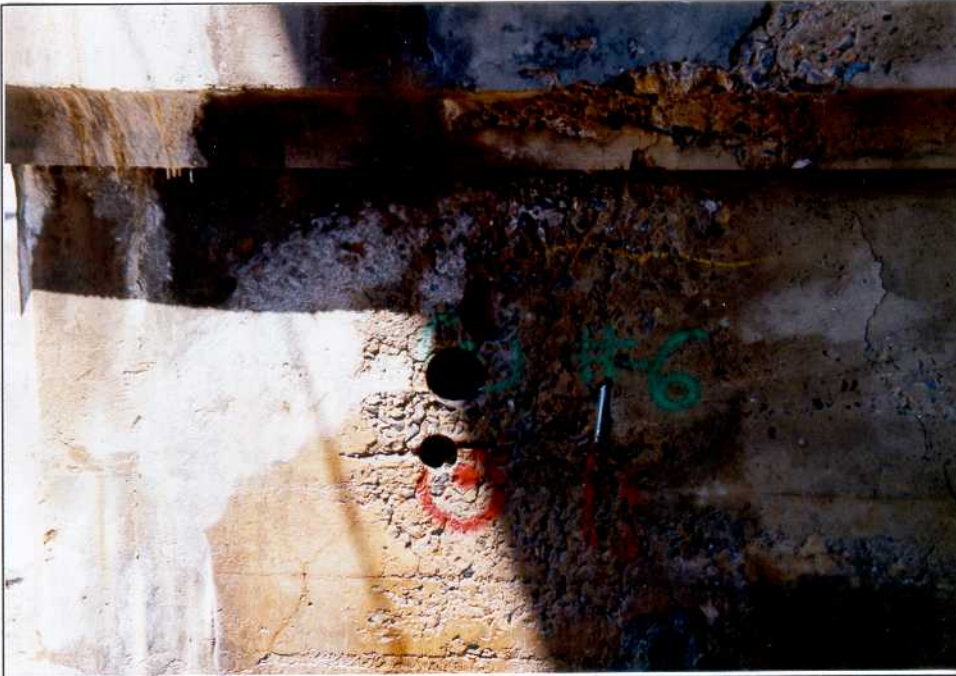
C216-13

PIER 10, 3' FROM UPSTREAM END, SOUTH SIDE, 4' BELOW  
TOP OF CAP - NOTE CORES H AND #6.

- Core G: No alkali silica reaction products observed at the time of this evaluation.
- Core H: Significant presence of gel formation in this sample. Multiple aggregate particles reacted and gel formation was observed at the periphery of aggregate particles and pockets in the paste. The occurrence of gel formation was noted throughout the entire sample. Expansion from gel formation caused multiple cracks in aggregate particles and micro fractures were noted in the paste.

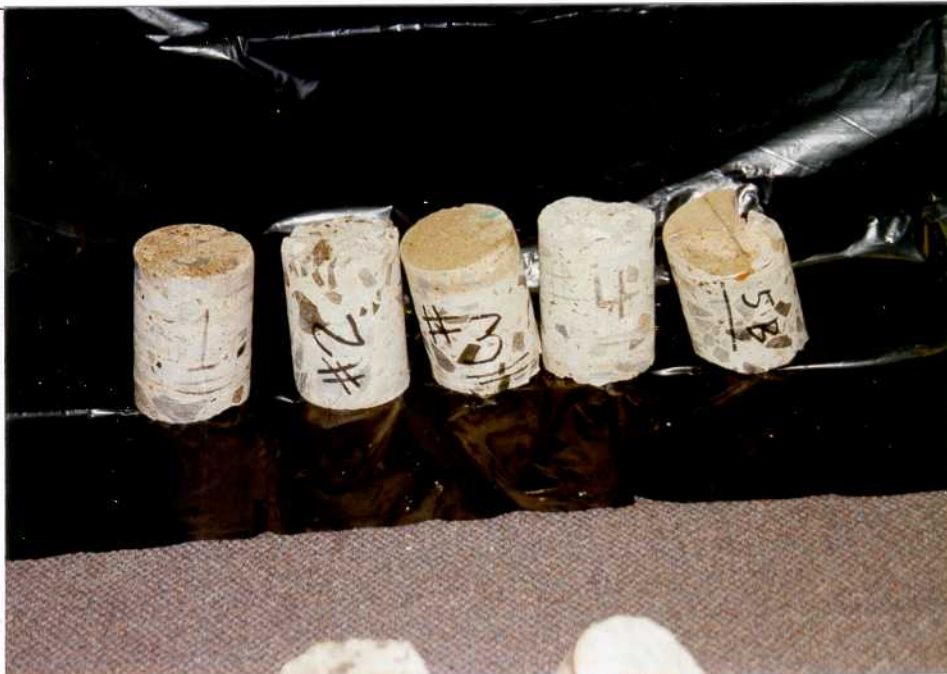
C218-2

CORES 1-5.

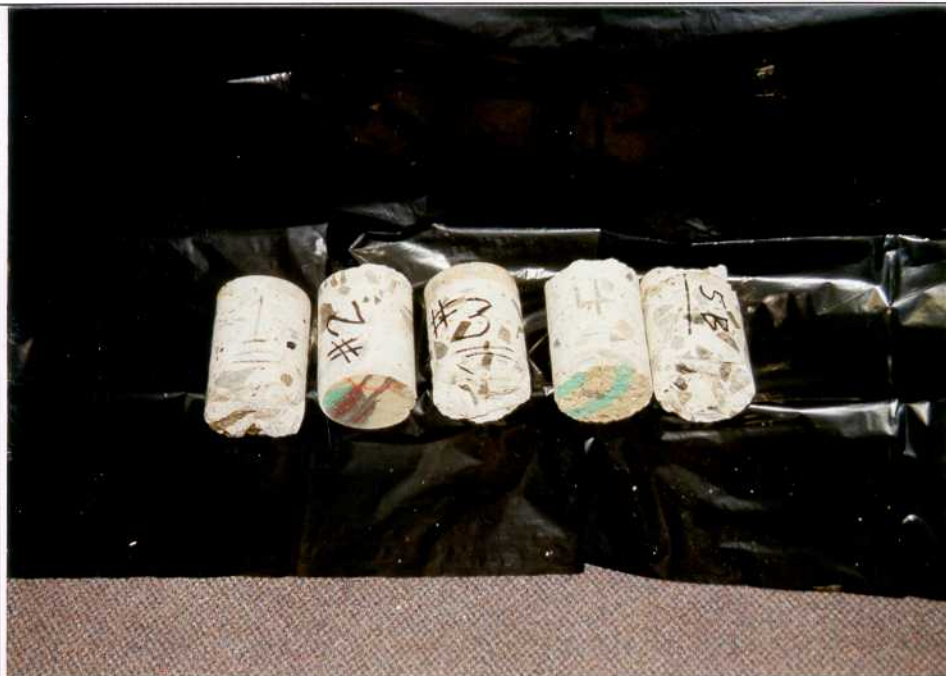
C218-1

CORES 1-5.

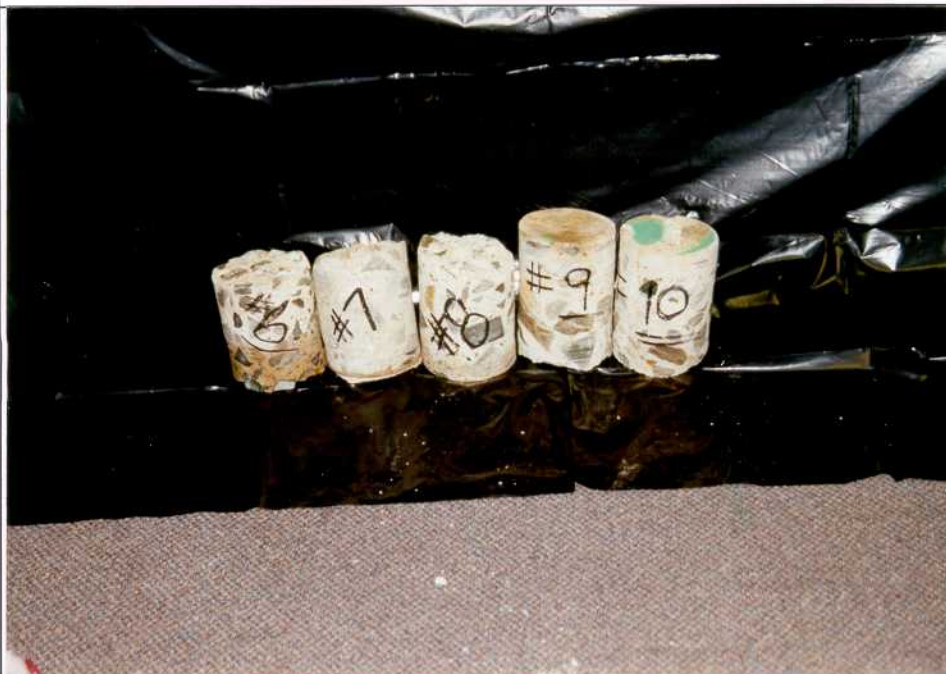
C218-3

CORES 6-10.

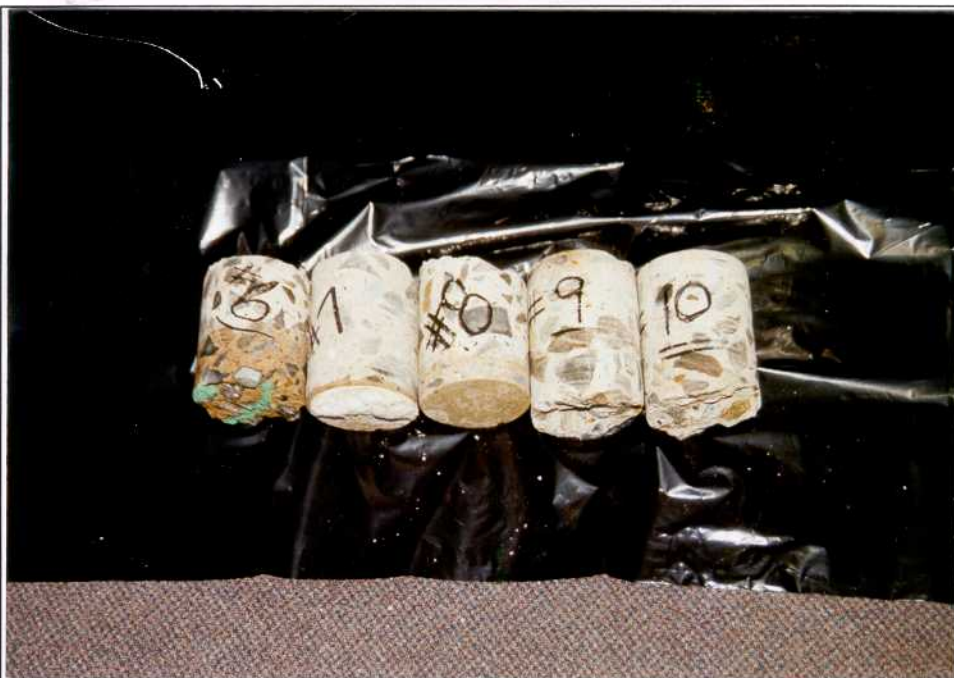
C218-4

CORES 6-10.

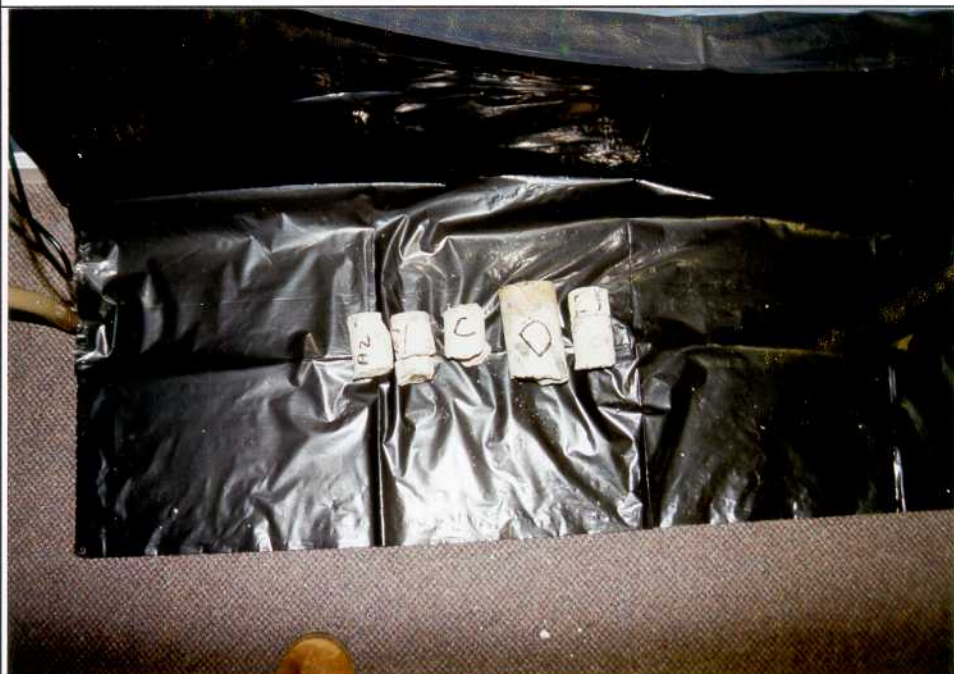
C218-6

CORES A, B, C, D AND E.

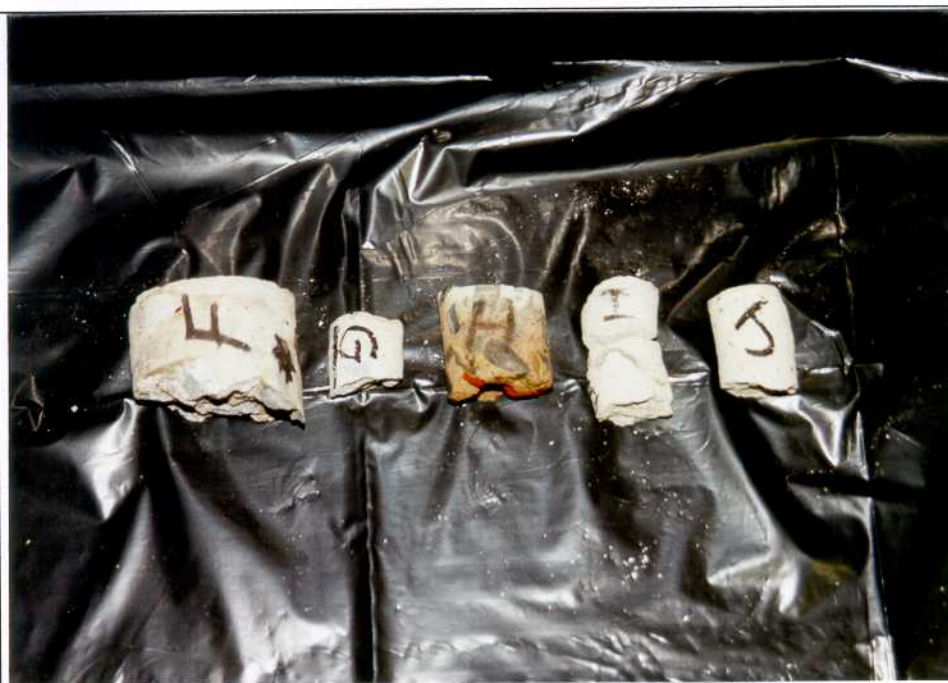
C218-8

CORES F, G, H, I AND J.
